Acoustic Thermometry of Ocean Climate (ATOC): Pioneer Seamount Source Installation

Technical Memorandum

APL-UW TM 3-96

April 1996

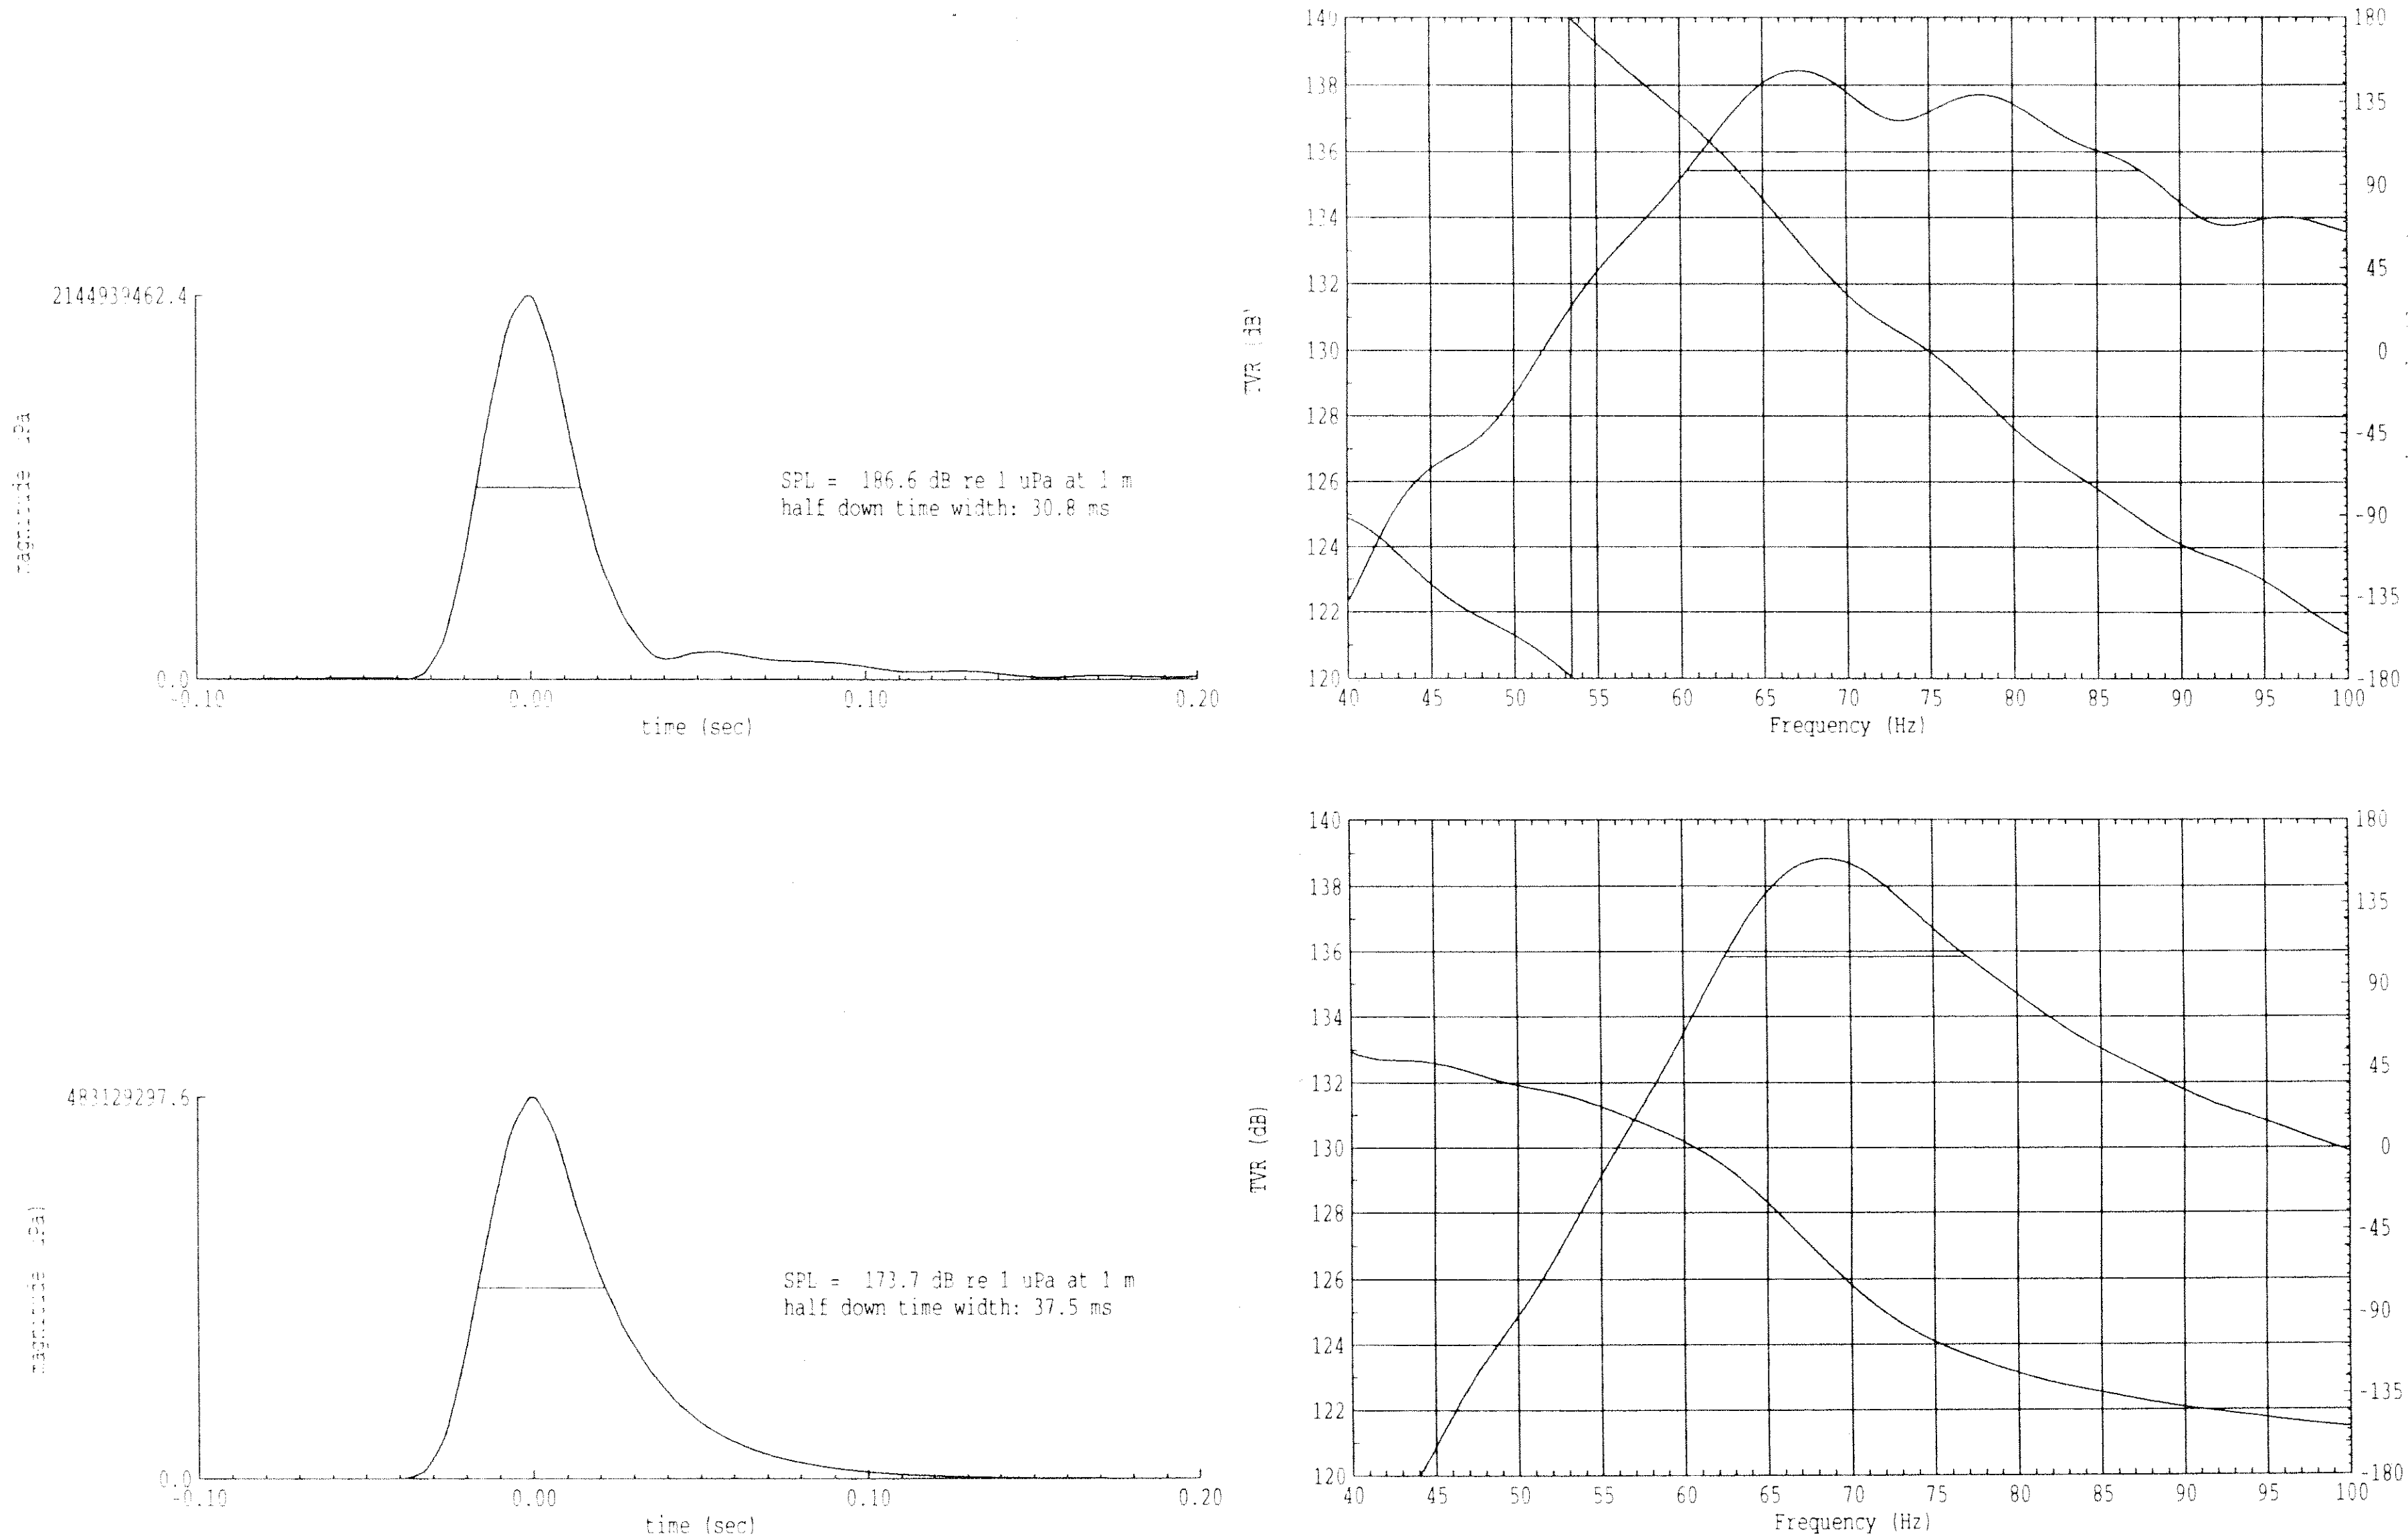
A short test m-sequence signal was sent, received on the monitoring hydrophones, and processed. The correlation peaks looked reasonable (see Figure 24a), with the absolute signal level (26 W) matching that expected given the nominal drive voltage (263 Vrms, 400 V peak for 27 nmi of cable) and distance. Further analysis revealed that the correlation peak was quite "clean," with a 3-dB width of 30.8 ms and low shoulders (a 20-dB width of 58.3 ms). This width is smaller than that predicted for a free field standard m-sequence signal (a 3-dB width of 37.5 ms and a 20-dB width of 85.8 ms). The measured spectrum is indeed broader, with two peaks and a very shallow valley between them (Figure 25); the energy in the "new" peak on the high-frequency side of the main peak helps sharpen the time-domain pulse. This peak width of 30.8 ms can be compared with the peak width of 28.3 ms obtained in the free field using signal shaping during the ATOC Acoustic Engineering Test (Howe, 1994). After much discussion, one possible explanation for these effects—the unexpected shape of the impedance plot, the spectral plot, and corresponding time-domain pulse—may be the presence of the bottom, which is not included in the source model. More will be said about this later.

Figure 24. Acoustic reception of one of the first source transmissions. (a) Measured pulse, (b) measured spectrum, (c) modeled pulse, and (d) modeled spectrum.

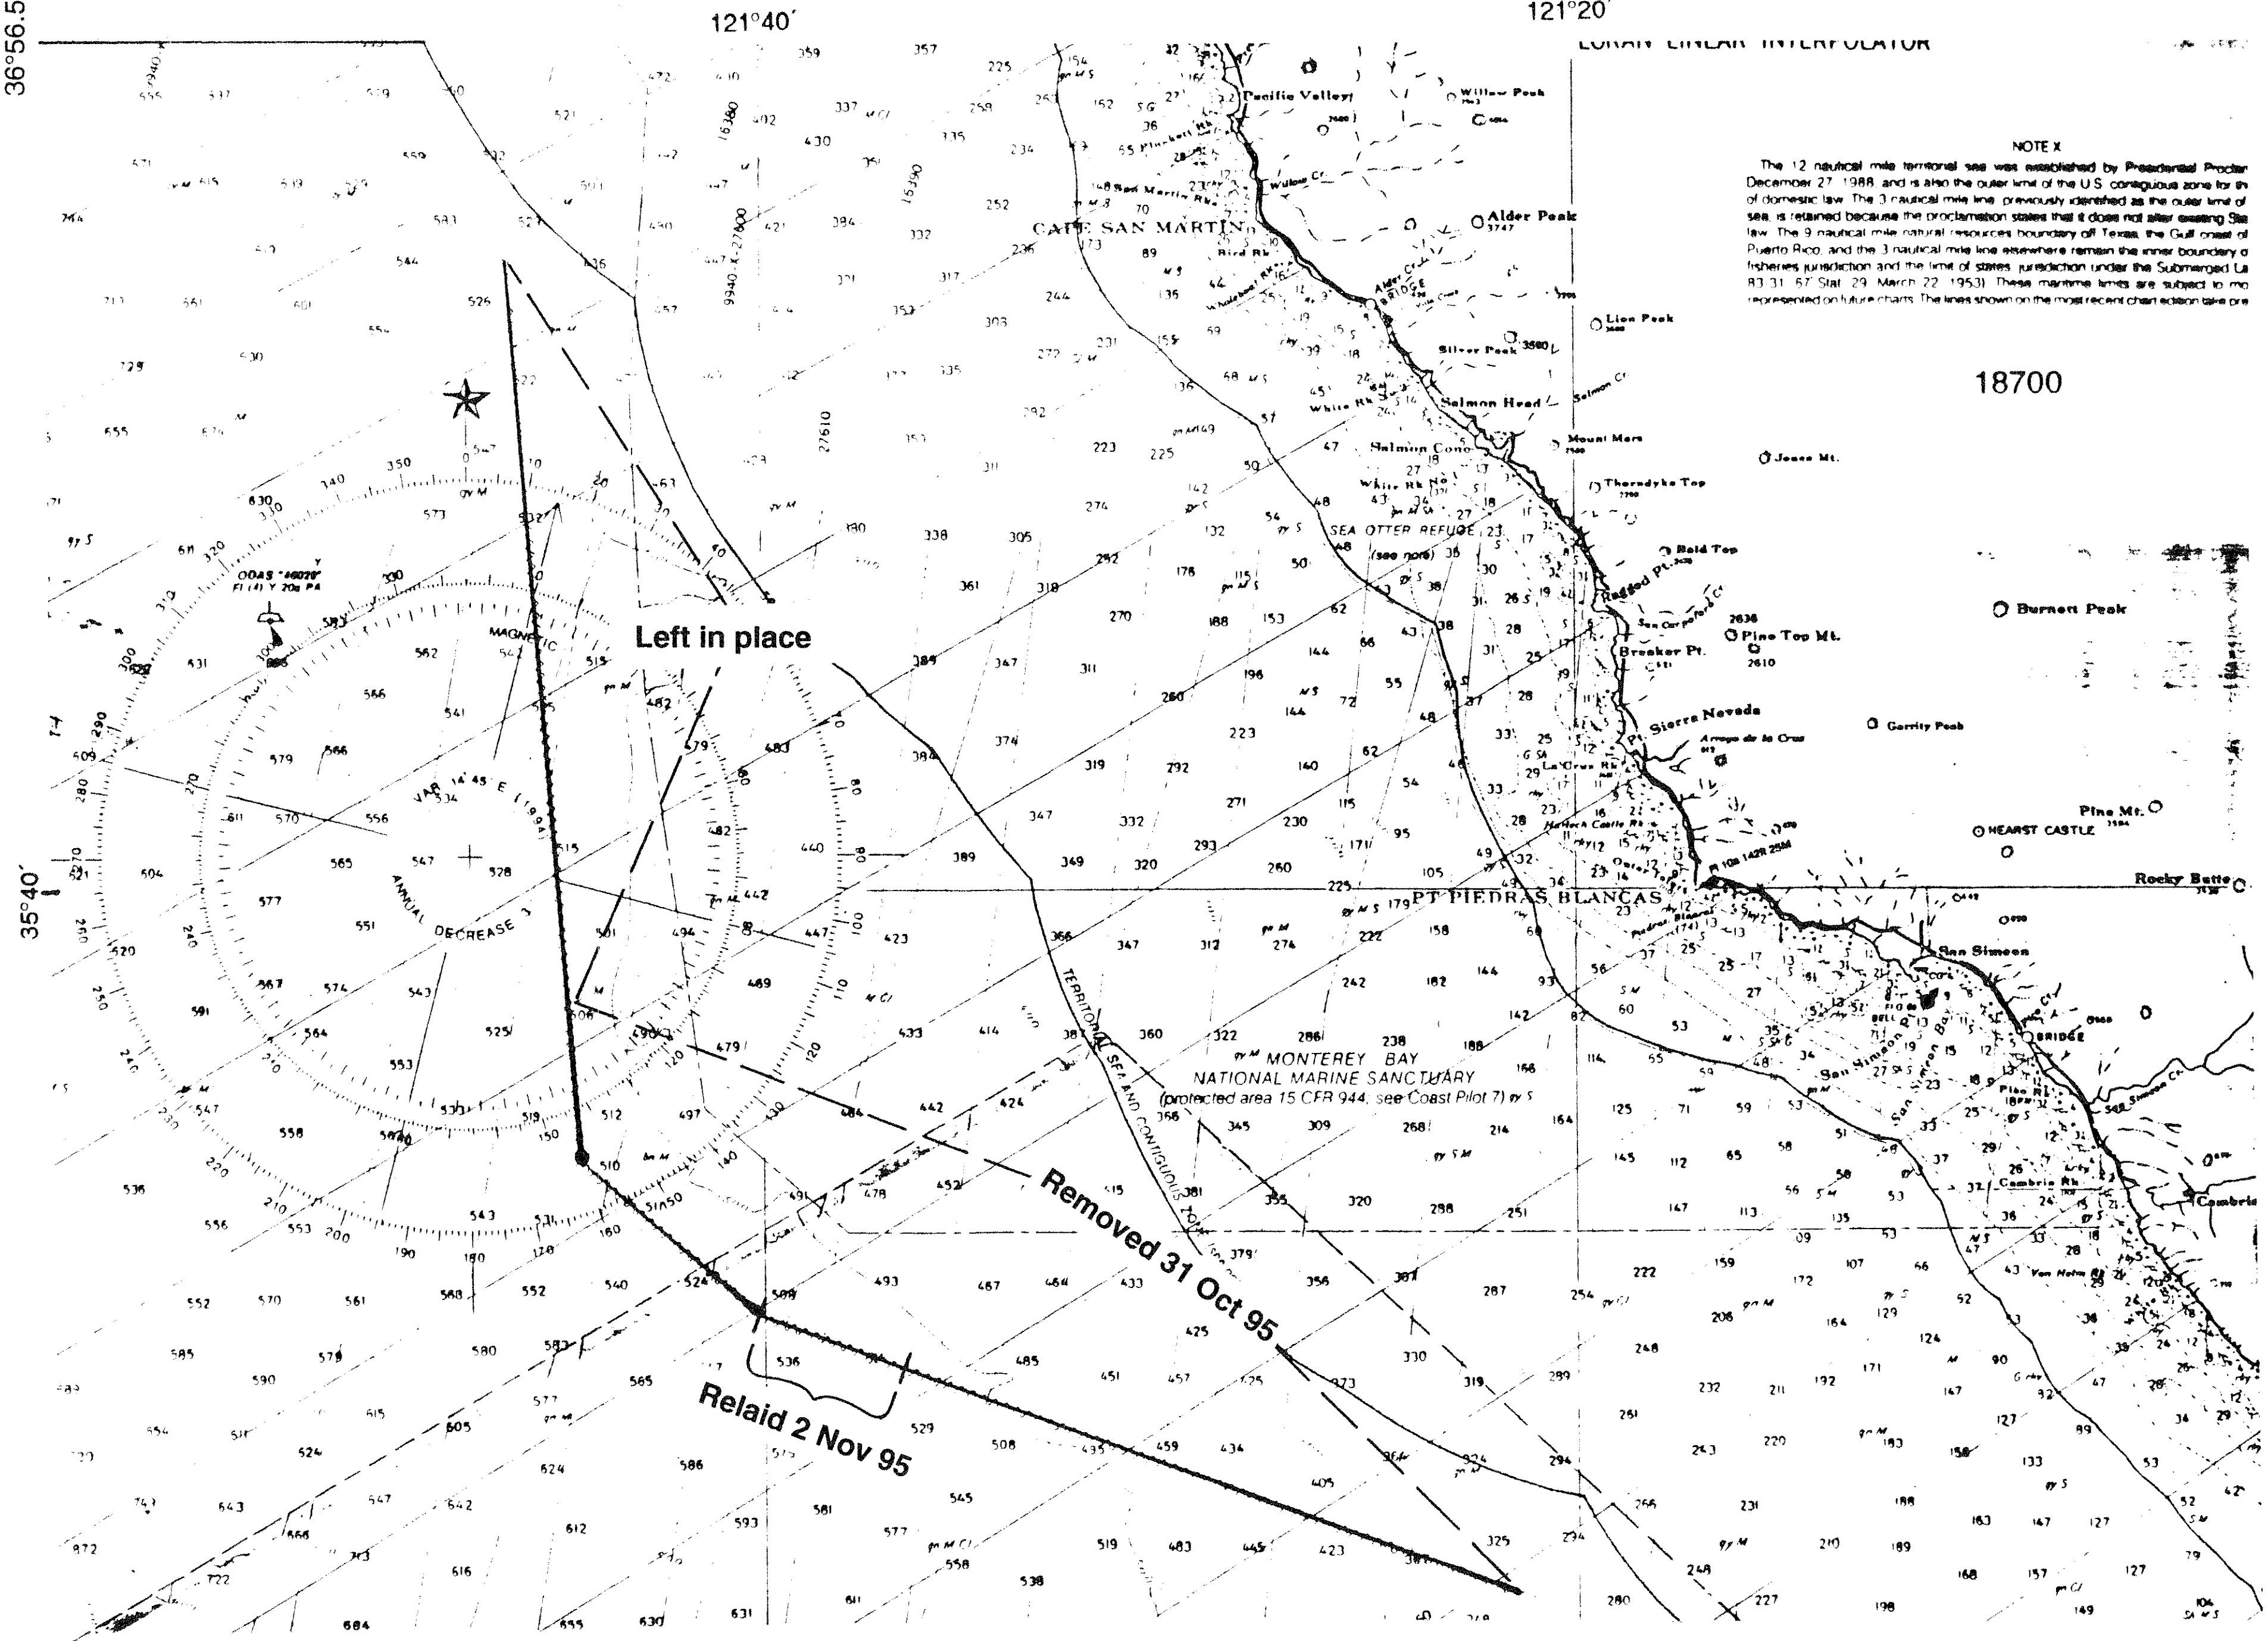
Figure 25. San Simeon cable route. The section removed is indicated, as is the 4.5-km-long section replaced at the end of the operation.

Grappling was necessary to recover the cable stowed off San Simeon, since there was no recovery release. The cable route is shown in Figure 25, and the cable information is given in Appendix C; the cable-route coordinates are given in Appendix F. Recovery began at the shallow (550-m), southern end. Grappling of the nylon recovery line was successful on the first try. Cable recovery was done at 2 knots. After the correct length was recovered, the cable was cut and the wet end sealed before being lowered back down with the nylon recovery line. This cable was in excellent condition; mud was found on the grappling chain.

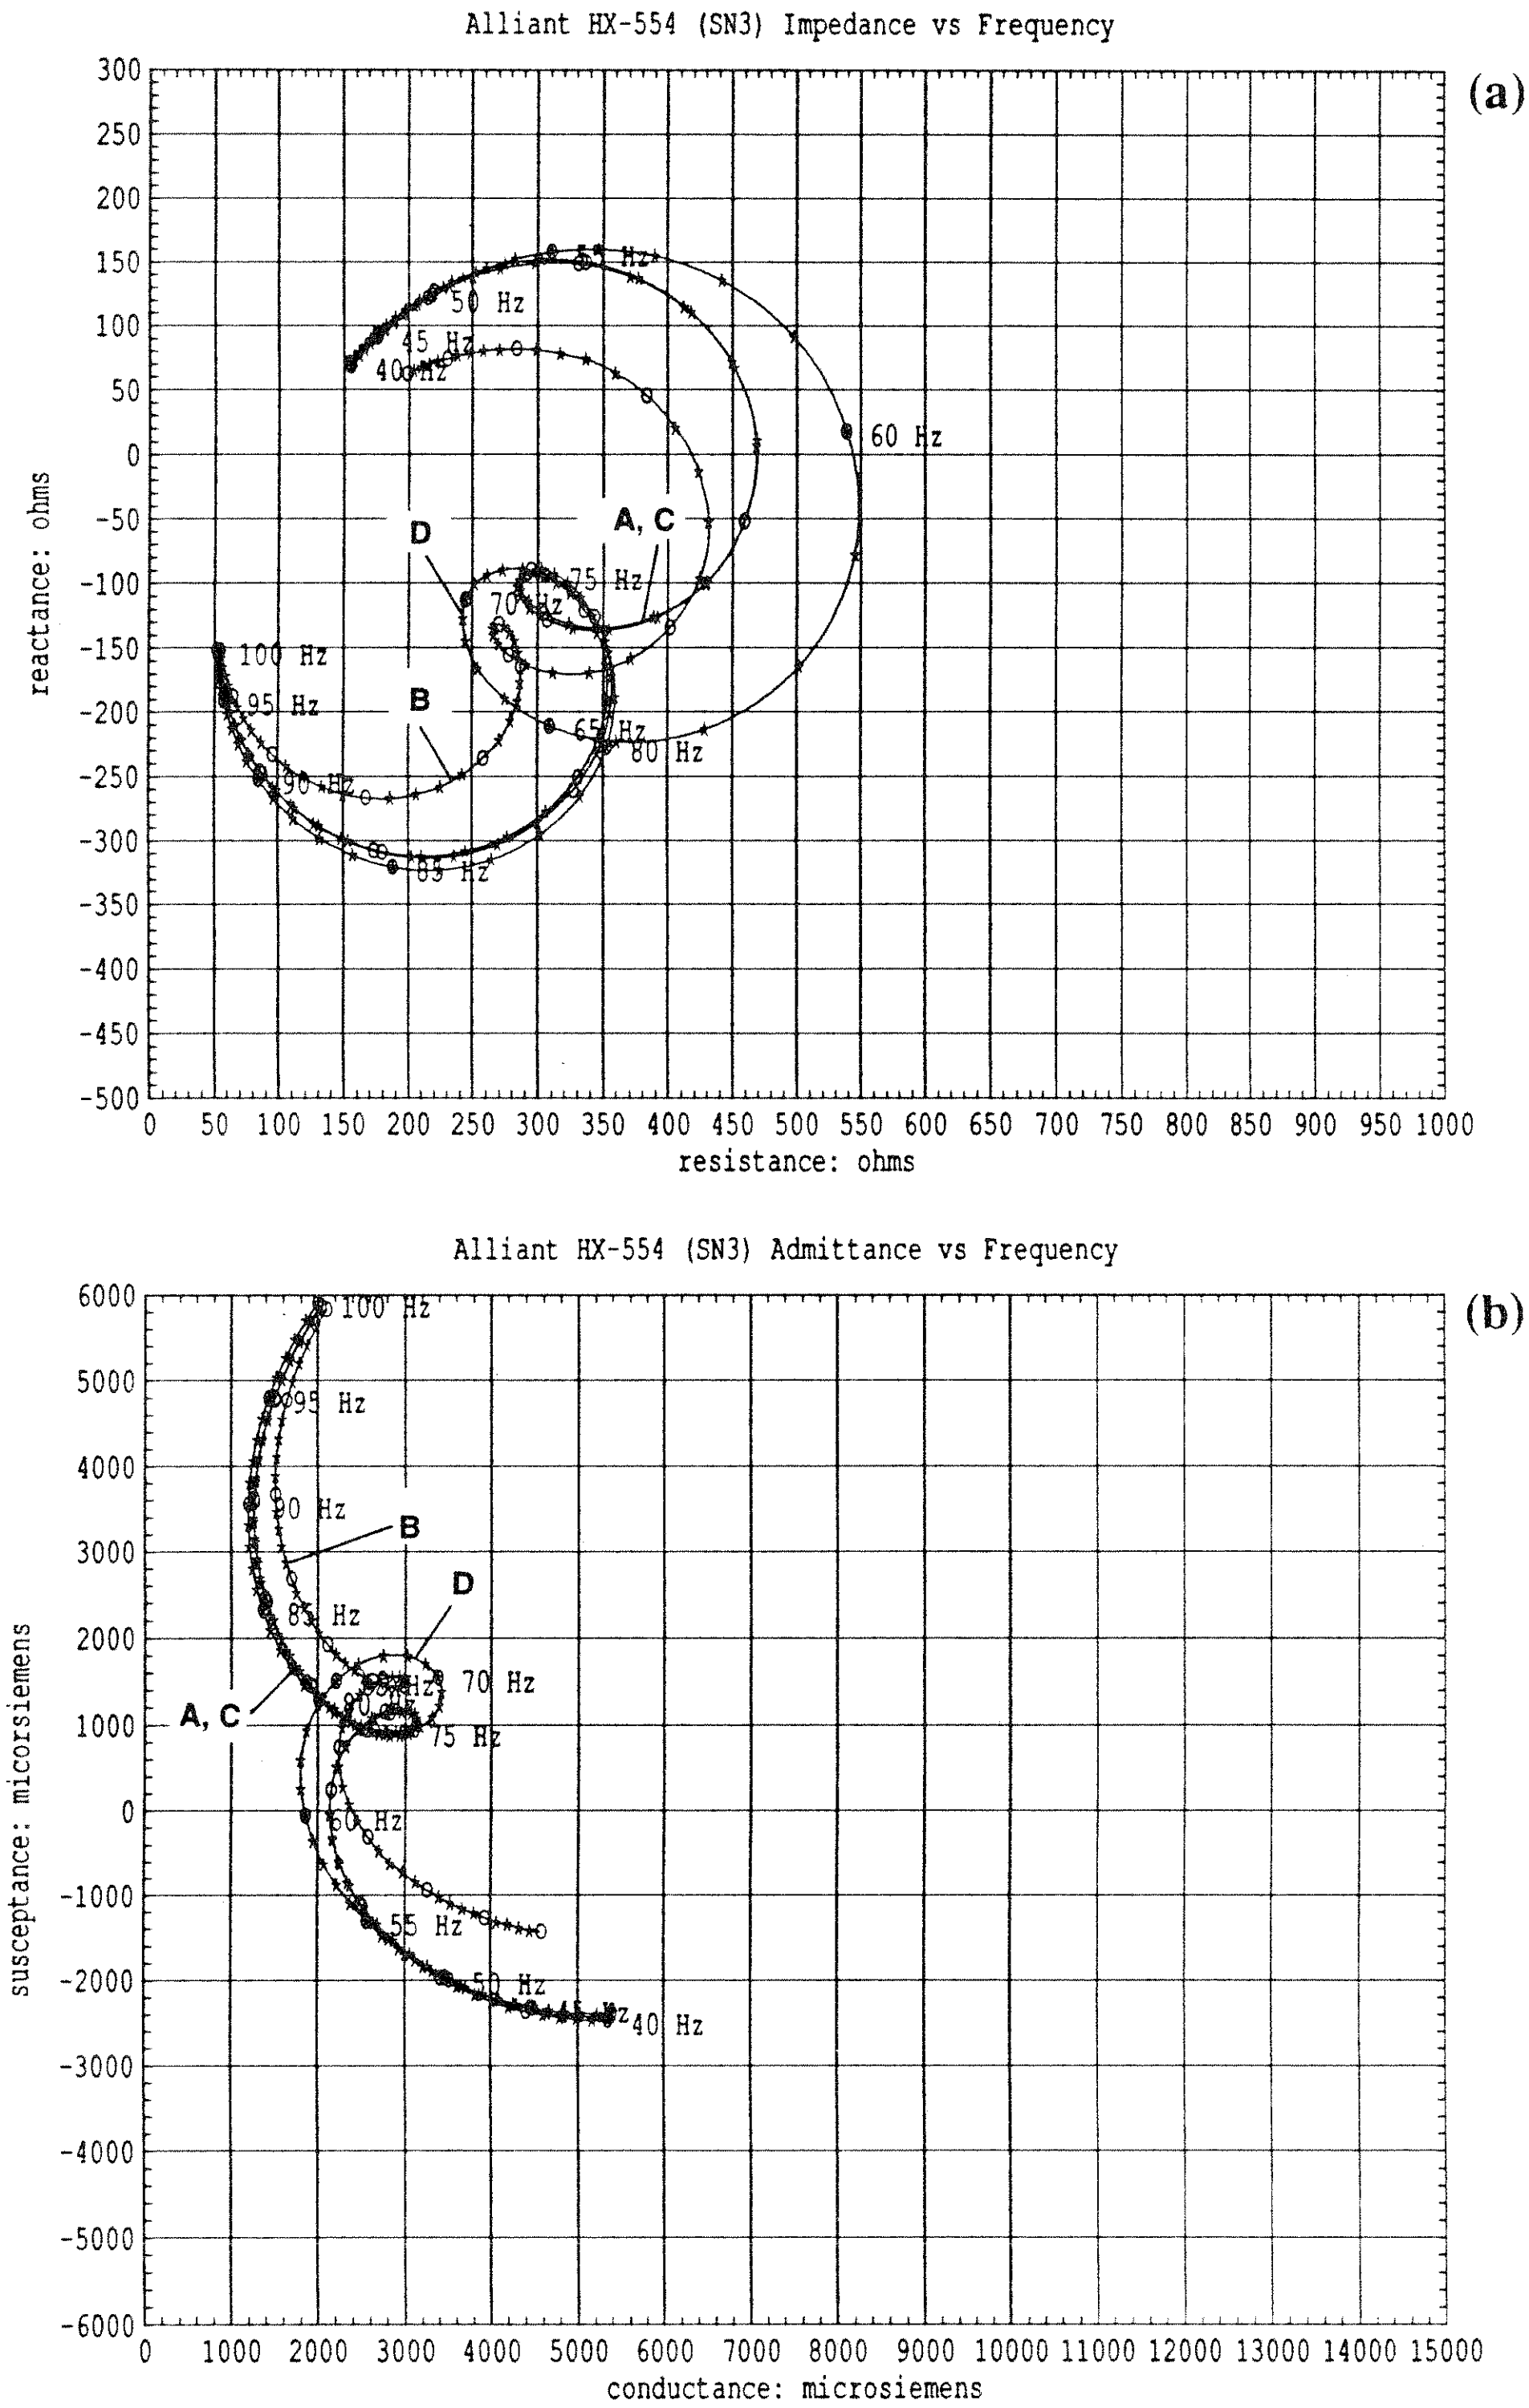
To complicate the situation, on 20 November the impedance function of the source began changing. The frequency of the source-impedance measurement was increased to once every half hour. The receiver was left operating for the 20 minutes between measurements. In an effort to localize the cause of the change, the receiver was turned off (no dc power was sent down the cable); after a few hours, the source impedance seemed to stabilize back closer to its original shape. Also, on 21 November, the receiver started to draw a variable amount of current, peaking at 0.95 A rather than the normal 0.70 A, and the sensor frequencies became erratic. Primarily because of the latter, but also because of all the problems described above, the receiver was turned off permanently the afternoon of 21 November. No really satisfactory explanation of why the receiver should affect the source-impedance measurements has been found (if, indeed, there was a real correlation). Kurt Metzger has suggested that the dc power affected, via electrolysis, the condition of the return shield on the cable, thereby affecting the ground for the source as well.

Figure 26. Plots of (a) source impedance and (b) source admittance at four times: A, 1200 UTC on 15 November 1995 (day 319); B, 0715 UTC on 22 November 1995 (day 326); C, 1200 UTC on 29 January 1996 (day 029); D, 1600 UTC on 1 February 1996 (day 032). Curve A is representative of the time following installation. Curve B is representative of the time when the source VLA was deteriorating. Curve C is representative of the time after the VLA was turned off and through 0800 UTC on 31 January 1996, and is nearly the same as curve A. Curve D is representative of the time after 1200 UTC on 31 January 1996.
